APPENDIX C

**BLDG. 1003
PHOTOGRAPHS, EVALUATION, SEISMIC ANALYSIS,
DEFICIENCIES AND COST**

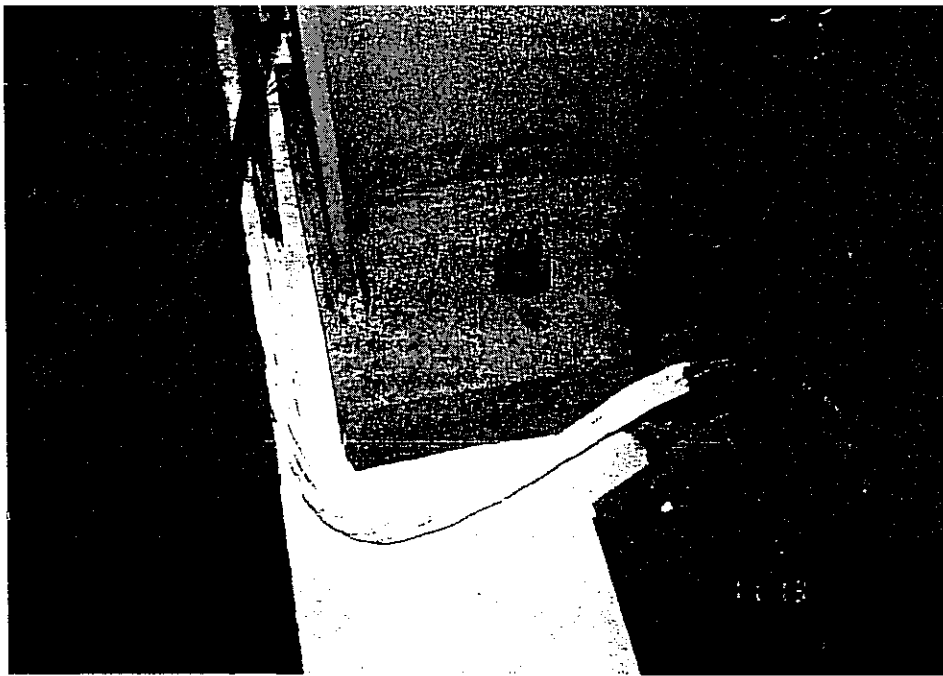
Photo 14. Typical column base anchorage to grade beam as seen on the ground floor mechanical room. Notice the connection and bolt installation are not designed as a moment connection.

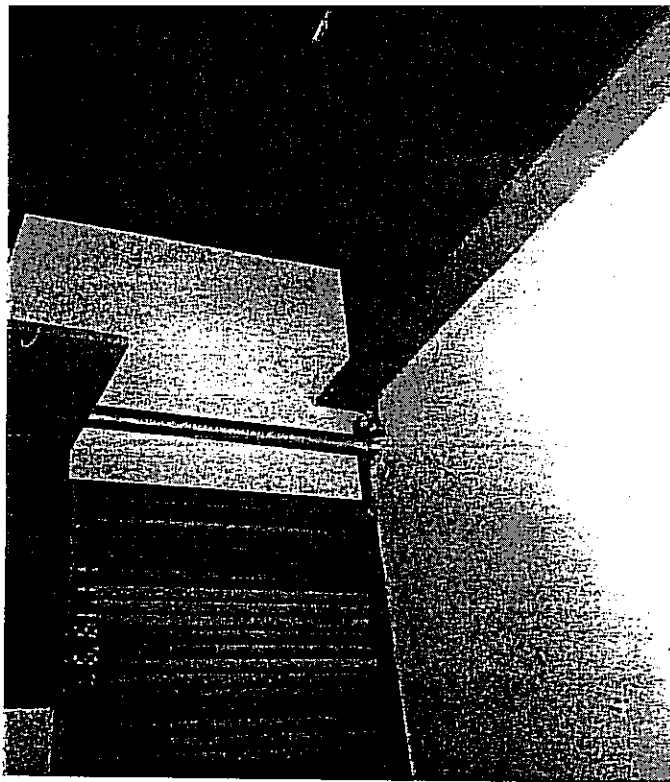
Photo 20. Typical connection of floor beams to column top. Notice the connection is not designed as a moment resistant connection. The steel deck floor is tack welded to the floor joist.

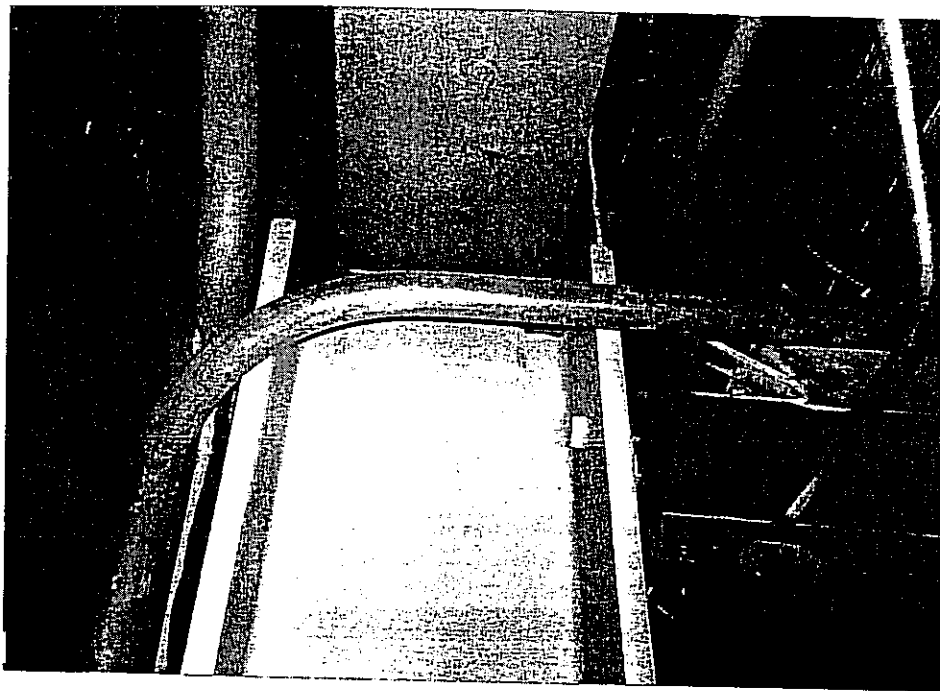
Photo 22. Another view of the connection of floor beams to column top. Again, notice the connection is not designed as a moment resistant connection.

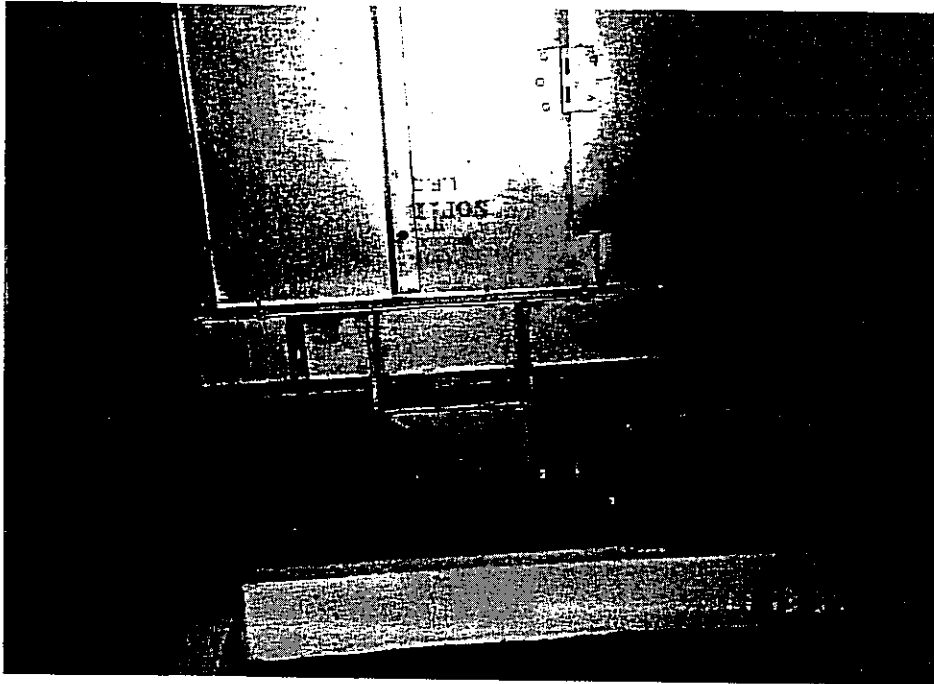
Photo 33. This other type of anchorage for the mechanical equipment provides vibration isolation and allows lateral restraint with a dampening effect. This anchor type is recommended to limit horizontal and vertical motion while absorbing stresses to minimize damage to equipment, piping connections or foundation.

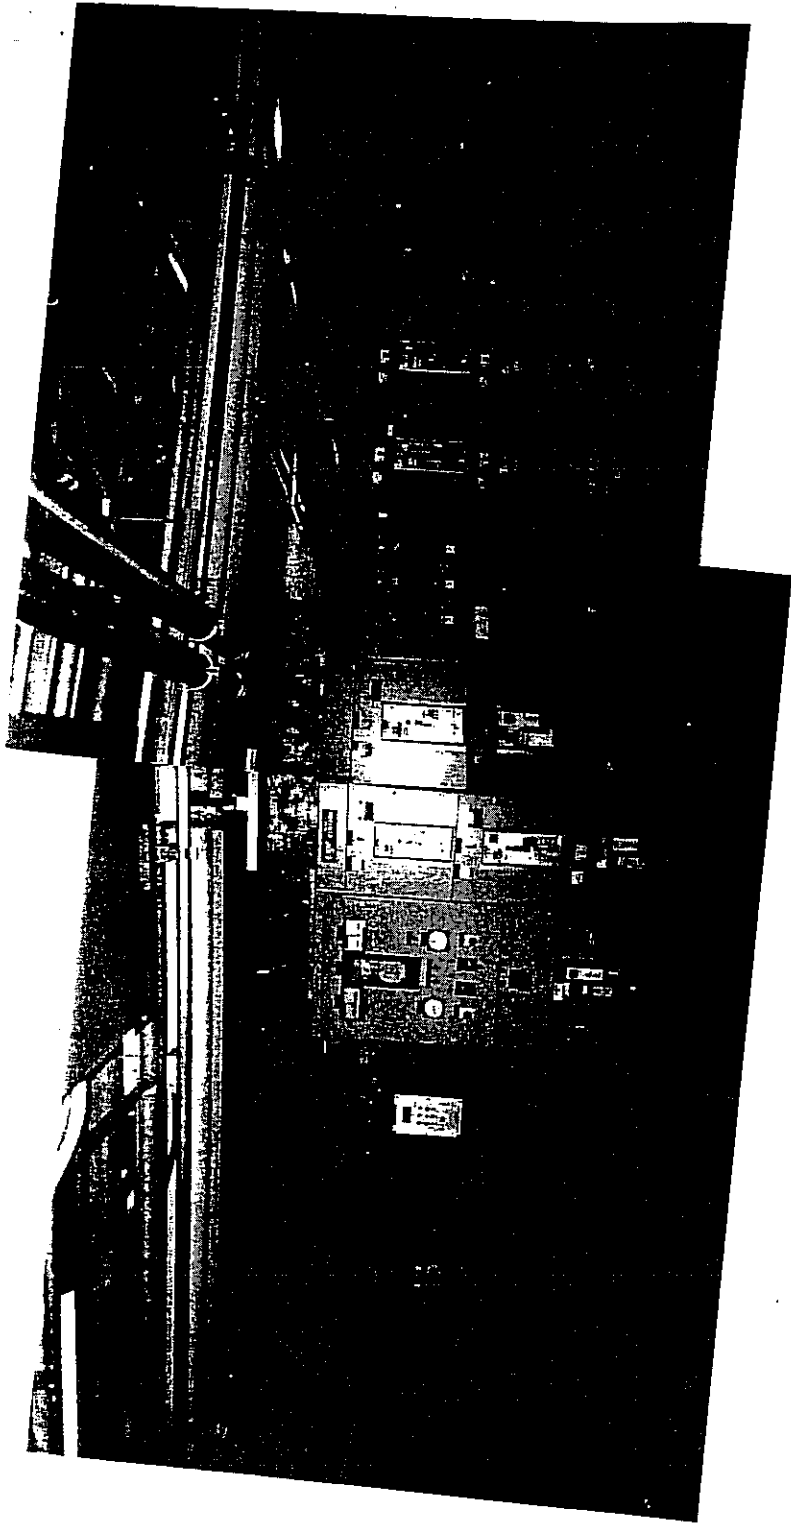
Photo 36. Electrical and mechanical equipment in the Mezzanine floor. It is unknown whether the equipment is anchored and the anchors are concealed within the metal cabinetry. The piping and conduits above are properly attached.

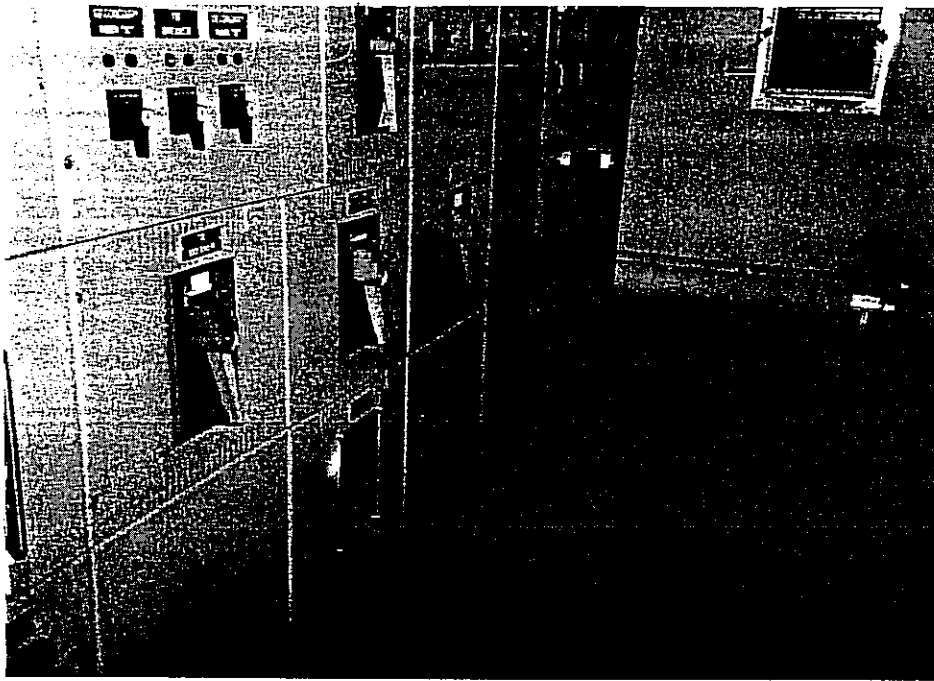
Photo 37. More equipment and furniture in the Mezzanine floor with rigid anchors directly attached to the floor. There is no pad under the equipment. The floor shows minor cracking as signs of distress caused by the anchors.

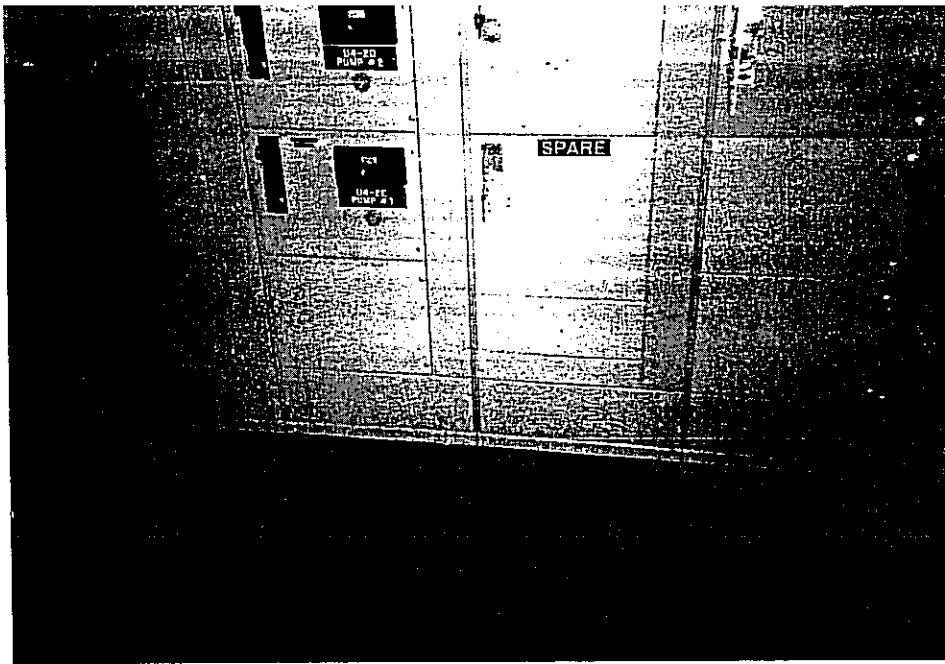
Photo 39. More equipment in the Mezzanine floor. It is unknown whether the equipment is anchored and the anchors are concealed within the metal cabinetry.

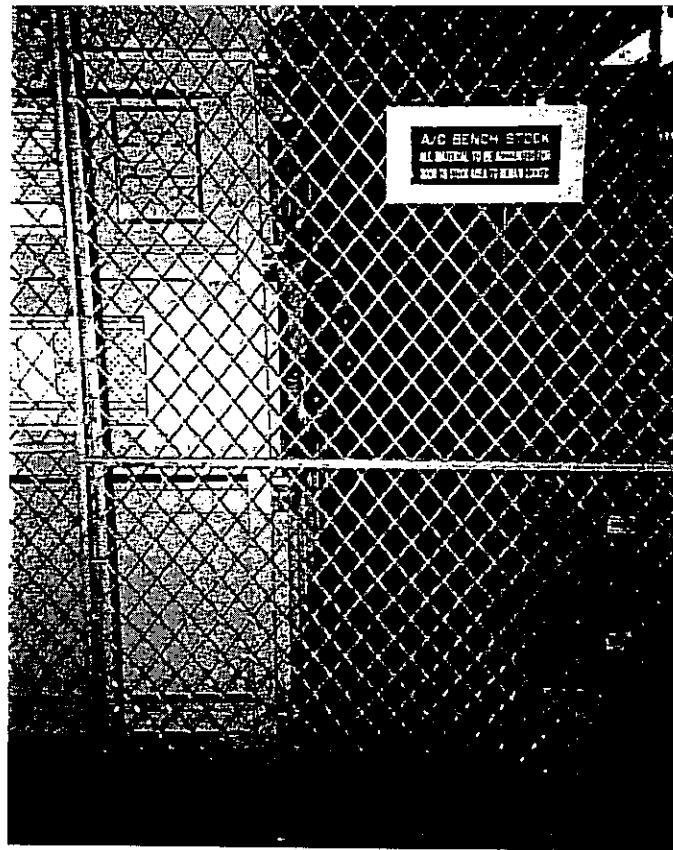
Photo 43. Designated equipment storage areas are fenced with chain-link fences properly anchored at the bottom. Anchoring of the top is recommended.

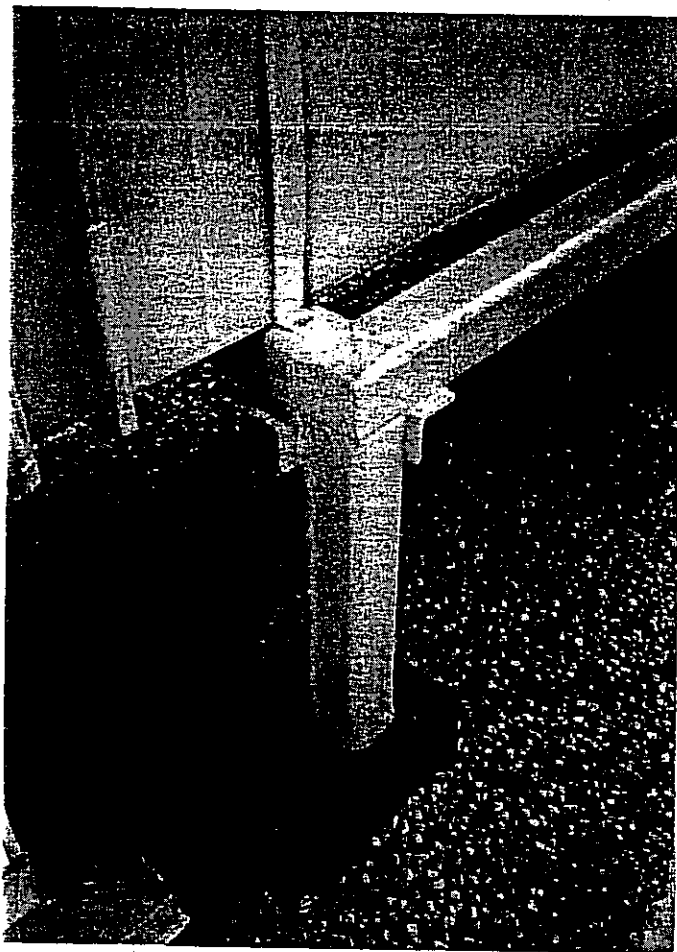
Photo 49. Some equipment supports at the roof level are rigidly anchored to the roof structure. Lateral bracing in both directions is recommended for legs supporting equipment over 18 inches above floor level.
